Copper Mountain Mine tailings dam safety review supplement

Daniel Brox^{1,*}¹ Independent researcher, Canada.*Correspondencia: dbrox@ece.ubc.ca

Copper Mountain Mine tailings dam slope stability research based on recommendations of the 2021 Tetra Tech Dam Safety Review, including computation of tailings dam factors of safety, satellite imagery, steady state and transient seepage analyses, and assessment of internal erosion risk. 3D dam factors of safety satisfy BC's normal operating legal requirement of 1.5 but are in possible violation of the post-seismic legal requirement of 1.2.

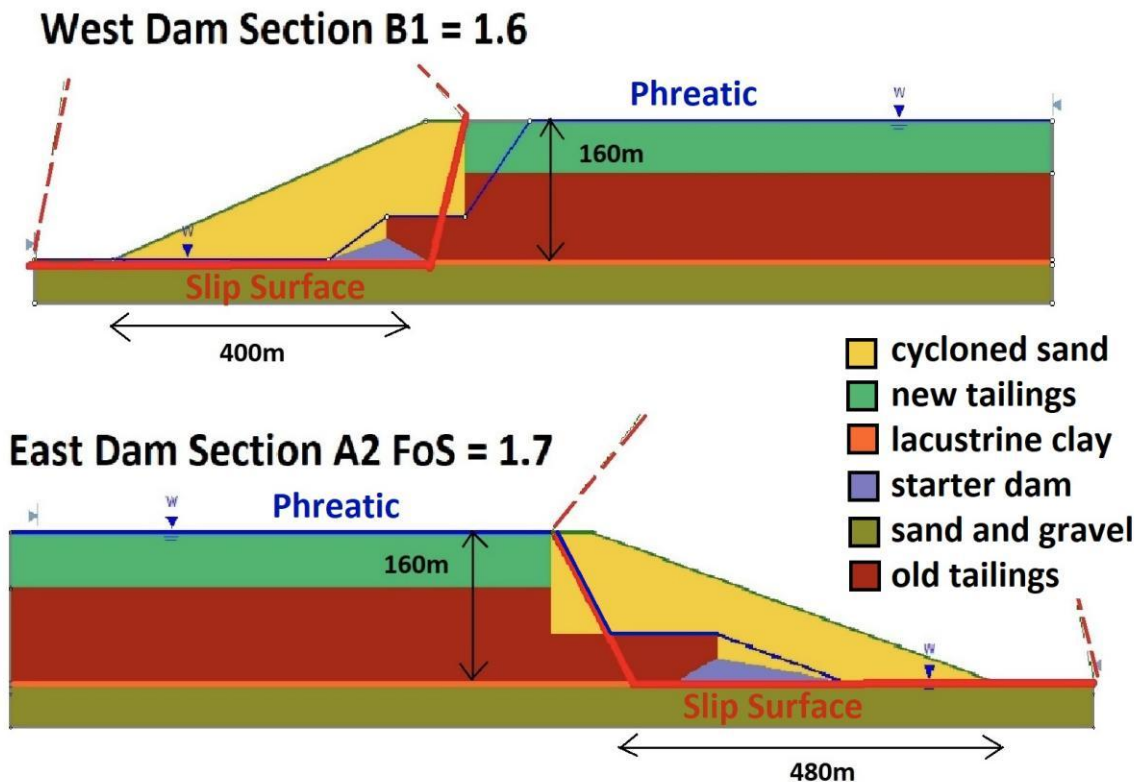
Figure 1 shows the FoS=1.6 result of applying the 2D Morgenstern-Price limit equilibrium method in Rocscience Slide2 to compute the FoS of West Dam cross section B1 using an approximation of the 2020 KCB model, including the reported phreatic surface level, assignment of drained Mohr-Coulomb material shear strengths to dam construction and sand/gravel foundation

Figure 1 shows the FoS=1.7 result of applying the 2D Morgenstern-Price limit equilibrium method to compute the FoS of East Dam cross section A2 using a model approximating the 2020 KCB model, including the reported phreatic surface level, assignment of drained Mohr-Coulomb material shear strengths to dam construction and sand/gravel foundation materials, assignment of undrained SHANSEP material shear strength to lacustrine clay foundation material, and the reported critical slip surface. It is important to note that neither the West nor East Dam 2D FoS computations reported here used a computer search algorithm to determine the dam critical slip surface, implying these 2D FoS values are overreported. It is also noted that in 2016, AMEC reported an end-of-construction FoS of 1.3 for a model of East Dam cross section A2 in which a continuous lacustrine clay layer was present in the foundation, while in 2020, KCB reported an FoS of 1.9 for the same cross section at time-of-construction.

Figure 1. Morgenstern-Price computed FoS for West and East Dam 2D cross sections B1 and A2.

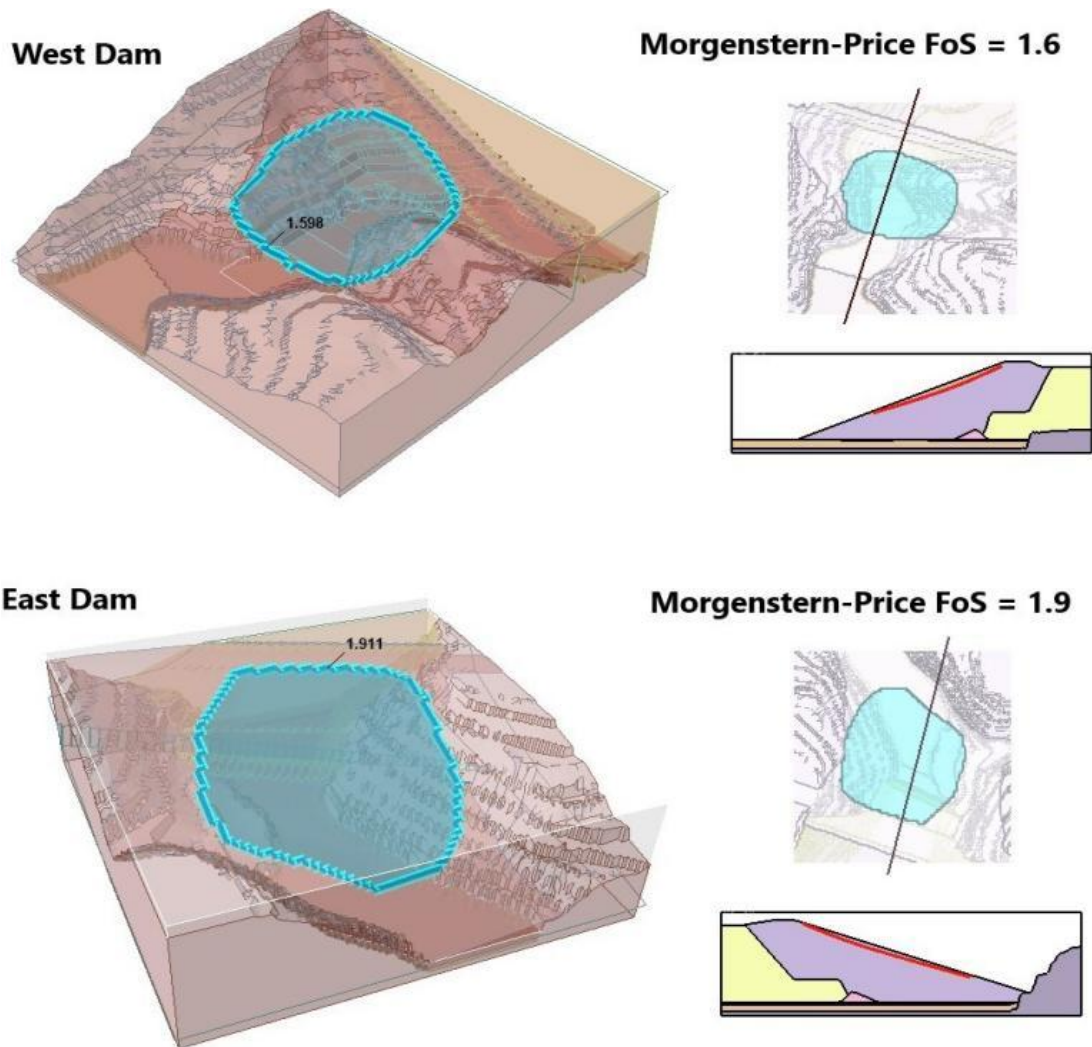
Figure 2. West Dam and East Dam 2025 3D Morgenstern-Price FoS values computed for critical slip surfaces determined by Rocscience Slide3 classic ellipsoidal particle swarm search. Phreatic surface levels are based on 2D FEFLOW seepage analysis of probable maximum flood conditions.

2025 3D limit equilibrium analysis FoS values for Copper Mountain Mine West and East Dams are 1.6 and 1.9 with assumption of phreatic surface levels based on 2023 piezometer data. Both these values are above the normal operating legal limit of 1.5, as specified by the Health and Reclamation Code for Mines in BC, but significantly lower than the values of 2.2 and 2.2 reported by KCB in 2020 (Government of BC, 2018). These results support the 2021 DSR recommendation to update Copper Mountain Mine TSF dam FoS computations, and suggest BC public access to tailings dam slope stability models could help minimize the chances of major tailings dam failures in the province going forward.

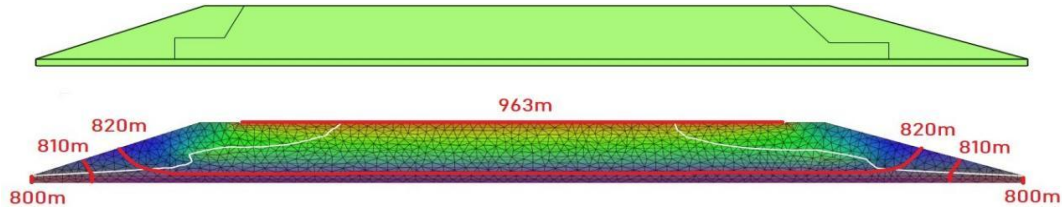
Figure 4 shows the FEFLOW computed 2023 steady state phreatic surface level and hydraulic head isolines for the entire TSF and its foundation analyzed as a simplified 2 dam system in which constructed drains are omitted, beach lengths are zero meters, and the material permeabilities listed in Table 5 have been used. This analysis indicates the 2023 hydraulic head in TSF foundation upstream of West and East starter dams is approximately constant at 810 m. The total seepage flows out of the West and East Dams are computed to be 1.4 L/s/m and 1.2 L/s/m, and in both cases more than 90 percent of this flow passes through the foundation. These seepage analysis results are in contrast to 2014 piezometer readings of VWP10-05W-3/VWP10-01E-3 in West/East Dam upstream foundations in excess of 835 m/845 m, pointing to the importance of accounting for transient seepage conditions and the effect of 3D TSF geometry on seepage flow, including any low permeability path from the TSF pond through the TSF abutments into the foundation (Klohn Crippen, 1998).

Figure 4. West/East Dam FEFLOW steady state analysis of 2023 2 dam system indicates hydraulic head in TSF foundation upstream of West and East starter dams is approximately constant at 810 m.

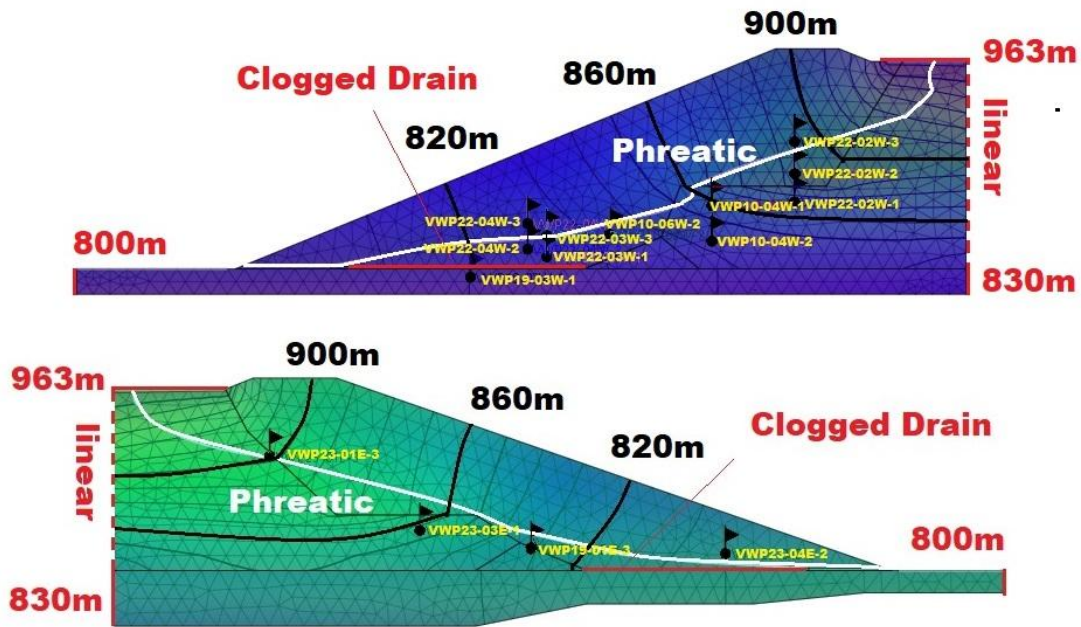
Figure 5 shows West/East Dam FEFLOW steady state seepage analyses with drain function and boundary conditions adjusted to obtain approximate agreement of hydraulic heads with 2023 readings of West/East Dam piezometer readings. For both dams, an upstream foundation total head of 830 m was assigned based on readings of piezometer VWP12-01E-2 and results of analyzing the 2 dam system. For the West Dam, to obtain agreement with downstream piezometer VWP22-04W-1 and VWP22-03W-3 readings of 811 m and 827.5 m, it was necessary to assume 100 m of the blanket/finger

Figure 5. West/East Dam FEFLOW 2023 steady state seepage analysis with drain function, boundary conditions, and material permeabilities calibrated to 2023 piezometer readings.

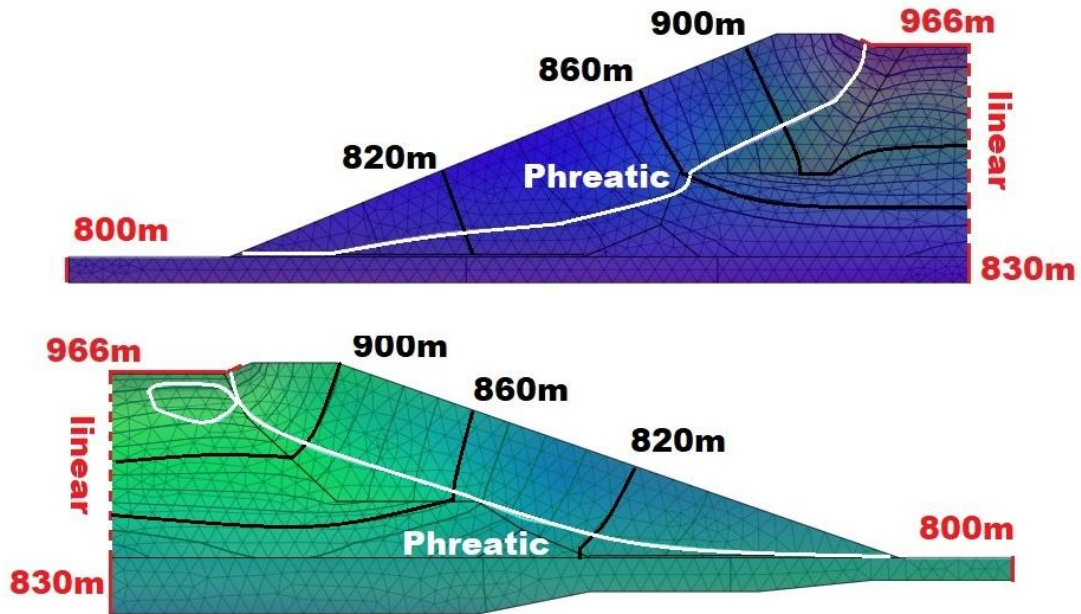
Figure 6. West/East Dam FEFLOW 2023 transient seepage analysis results 30 days after 72 hours probable maximum flood decreases dam freeboard by 3 m.

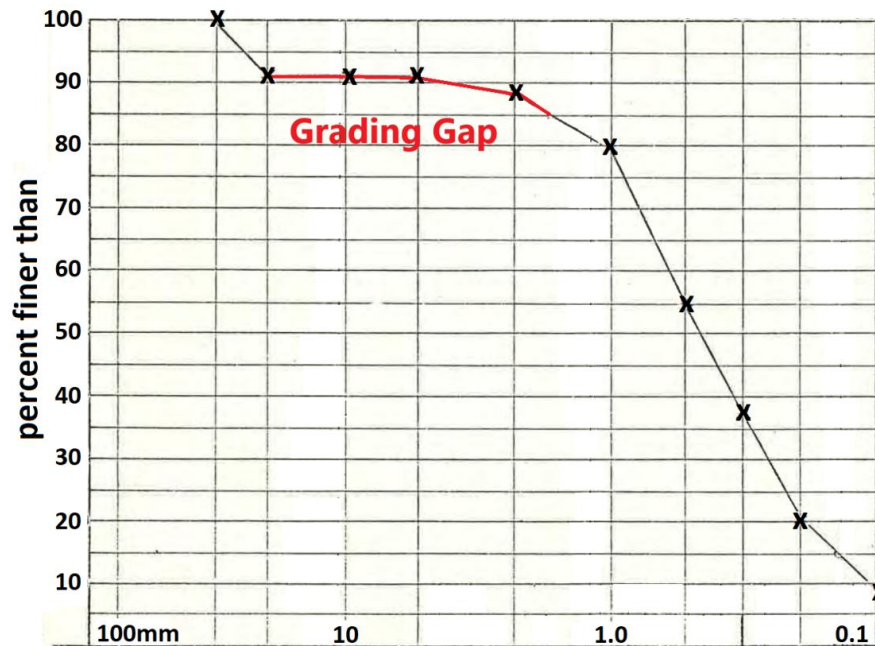
Figure 7. Grain size distribution curve for silty gravelly sand 17.2 to 18.7 feet deep in borehole SL-9 in the East Dam foundation.

A condition on grain size distribution of a material indicating initiation of suffusion is the Kezdi criterion, which states suffusion may initiate if the difference in percent fines content between grain sizes D and $4D$ is less than 15 percent (Kezdi, 1979). Based on the grain size distribution curve for silty gravelly sand recovered from borehole SL-9 in the East Dam foundation, shown in Figure 7, and the Kezdi criterion, the

foundation material is susceptible to suffusion because of a gap in grading between 2 and 20 mm grain sizes (Bechtel Ltd, 1971). In principle, this suffusion could result in transport of fine grained sand and/or clay material through the foundation contributing to West and/or East Dam drainage blanket and finger drain clogging (Fry, 2016).

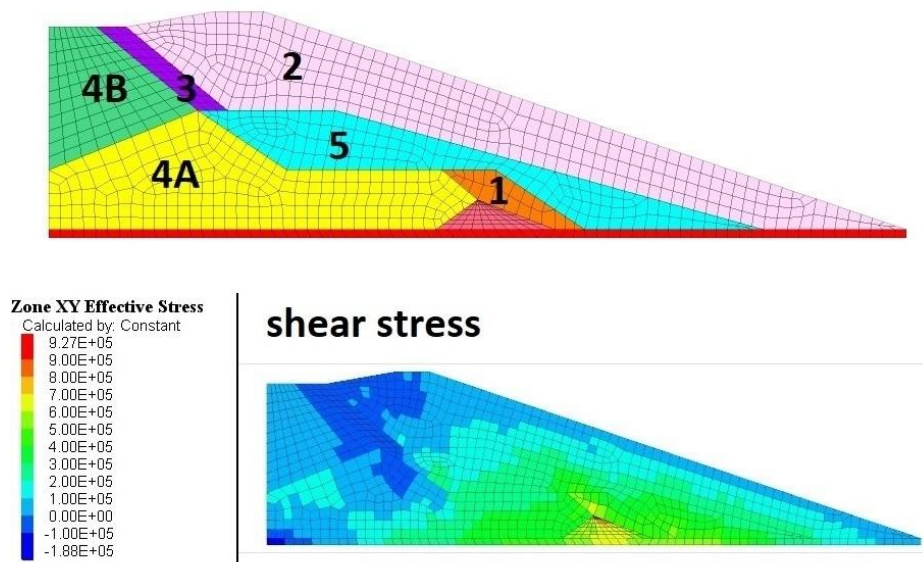
Figure 8. FLAC2D computation of shear stress in 2025 East Dam cross section A1 shows the shear stress in vicinity of starter dam and its foundation exceeds 100 kPa. Dam zone labels 1:compacted cycloned sand, 2:uncompacted cycloned sand, 3:tailings sand + cyclone overflow, 4:tailings slimes, 5:water saturated cycloned sand.

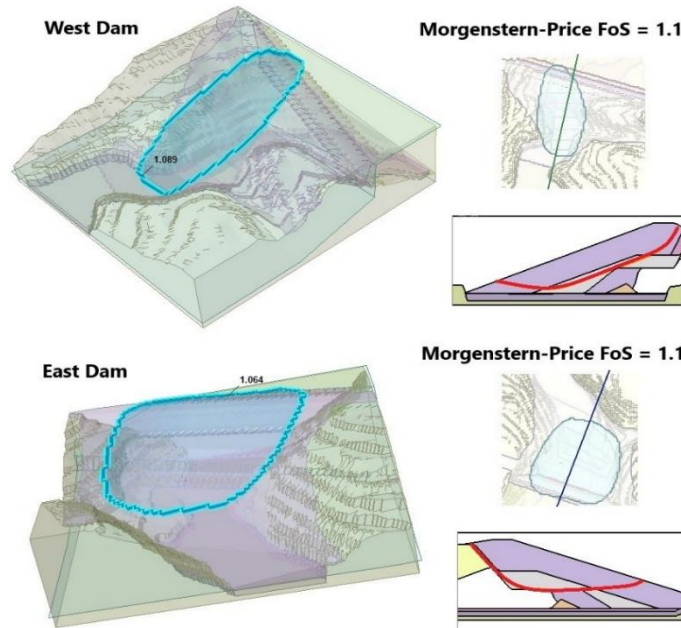
Figure 9. Post-liquefaction Morgenstern-Price FoS computation results in Slide3.

Another immediate concern is 2023 ADSI piezometer data indicating parts of the West and East Dam cycloned sand shells are water saturated, an occurrence highlighted as a liquefaction hazard by previous professional engineering investigations (Golder Associates, 1981). This data suggests assumption of peak undrained shear strength for cycloned sand in 3D FoS computations is not conservative, and for this reason, residual undrained shear strengths should be assigned to parts of the West and/or East Dam cycloned sand downstream slopes in post-liquefaction stability analyses. With conservative assignment of these strengths based on SPT testing, 3D post-liquefaction FoS values for both dams are less than 1.2, which is a violation of the Health, Safety, and Reclamation Code for Mines in BC seismic stability requirement. This result suggests instrumental
