Copper Mountain Mine tailings dam safety review supplement

Daniel Brox^{1,*}¹ Independent researcher, Canada.*Correspondencia: dbrox@ece.ubc.ca

Copper Mountain Mine tailings dam slope stability research based on recommendations of the 2021 Tetra Tech Dam Safety Review, including computation of tailings dam factors of safety, satellite imagery, steady state and transient seepage analyses, and assessment of internal erosion risk. 3D dam factors of safety satisfy BC's normal operating legal requirement of 1.5 but are in possible violation of the post-seismic legal requirement of 1.2.

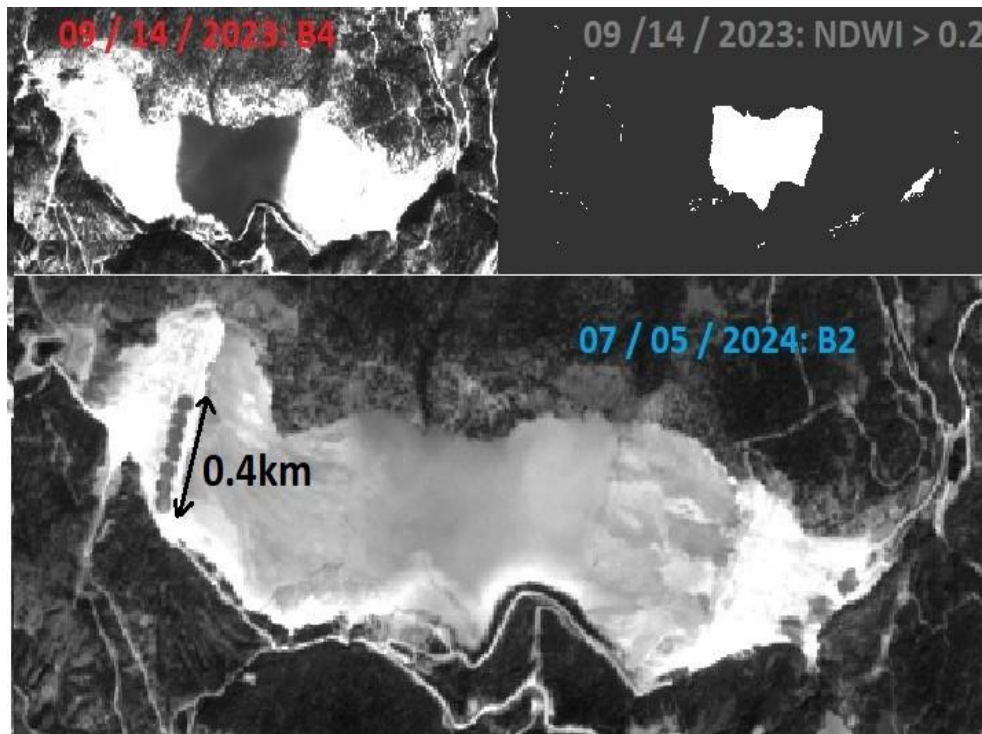
to detect presence of surface water, where B3 and B8 are the satellite measured reflectances in the green and near-infrared bands (Du, 2016, O’Donovan, 2022). Figure 3 shows images of the Copper Mountain Mine TSF on September 14, 2023, filtered in the red band B4 (left) and binary processed to display $NDWI > 0.2$ (right) to identify presence of surface water. Figure 3-bottom shows an image of the TSF on July 5, 2024, filtered through band B2 (blue-490 nm), in which circular surface structures of approximate diameter 60 m and 100 m with optical reflectivity less than surrounding dam material are visible on the West and East dam downstream slopes. This difference in reflectivity of blue light suggests the structures were not formed by a sprinkler system.

Figure 3. Sentinel-2 images Copper Mountain Mine TSF, dated 09/14/2023 (top), and 07/05/2024 (bottom). Top images show the TSF in red band B4 (left), in which boundaries of the tailings pond are clear, and the same image binary processed for the condition $NDWI > 0.2$ (right) to identify presence of water at the surface of the TSF. The bottom image shows the TSF in blue band (B2) in which 7 circular structures on the West Dam crest/downstream slope of approximate diameter 60 m and 3 circular structures on the East Dam downstream slope of approximate diameter 100 m are visible, and distinguishable from dam downstream slope, beach, and tailings pond materials by their reflectance in blue, red, and infrared bands.
